Earthquake Disaster Management in Different Countries - Influence of Culture of Region

S.K. Prasad*

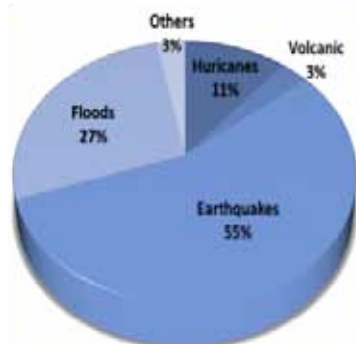
Fig. 1: Loss of life from natural disasters

Earthquakes are perhaps the most unpredictable and deadliest of all the natural disasters. It is impossible to predict when the next big earthquake strikes, for how long and at what location. Fig. 1 and Fig. 2 indicate the disastrous effects of earthquake compared to other natural disasters such as cyclone, flood, volcanic eruption, forest fire etc. Both the total number of deaths and economic loss to build environment exceed 50 % of total during earthquake. The Fig. 3 and Fig. 4 present the catastrophic effects of earthquake. Bhuj earthquake of 2001 that struck the western part of Gujarat on the republic day resulted in about twenty thousand loss of

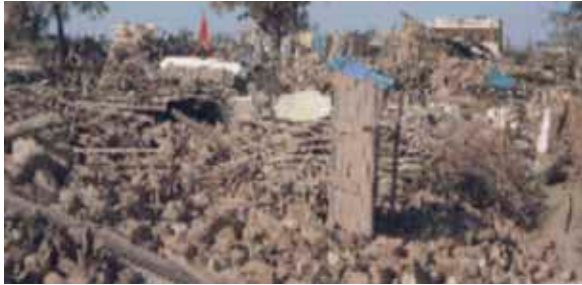
Fig. 3: Rapar town in Gujarat reduced to rubble after the Bhuj earthquake of 2001

life. Most of the infrastructure suffered serious damage and many towns and villages were reduced to rubble. Fig. 3 presents a small town called Rapar close to Bhuj immediately after the earthquake that was reduced to ruins. The situation of Port Au Prince, the capital city of Haiti (near West Indian Islands) is even worse. Out of the total population of 30 lakh people in Port Au Prince, 2.5 lakh people perished during one earthquake of 10th January 2010. Can we imagine any other disaster taking away so many lives (one out of twelve)? Infrastructure was completely reduced to devastation and life of the people was in dire state. Fire in the city could not be extinguished for days as there were no fire personnel

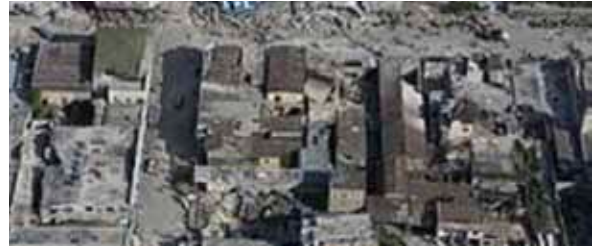
Fig. 4: Down town area of Port Au Prince, capital city of Haiti after the earthquake in 2010

to fight fire, dust in the atmosphere created by falling concrete and masonry structure could not be removed for days. Even the presidential palace could not survive the jolt. Worse was the fact that even after two years of the event, much of the debris was not removed indicating poor effort by the government to bring back the normalcy.

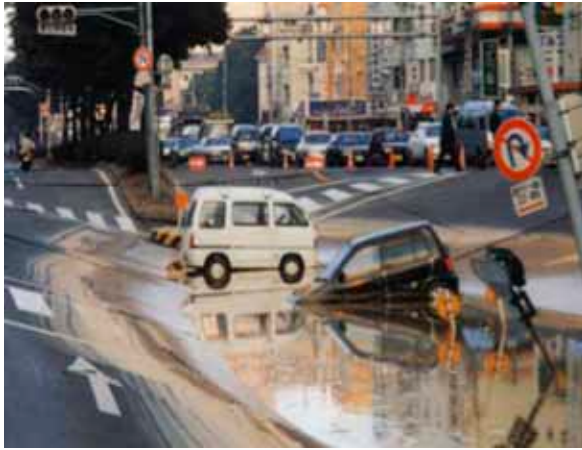
Fig. 5: Effect of liquefaction and collapse of underground metro station during Kobe earthquake of 1995

Fig. 5 presents cars taking bath in a pond. There never was a pond before the earthquake. Effect of Hyogo Ken Nambu earthquake in 1995 in Japan was such that an underground metro station in Kobe collapsed and foundation soil experienced liquefaction resulting in ground water moving up and ground experiencing settlement. Fig. 6 presents the case of four storeyed apartment buildings in group built of Reinforced Concrete framed construction at Kawagishi Cho in Niigata. The foundation soil comprised of saturated loose silty sand that experienced liquefaction during

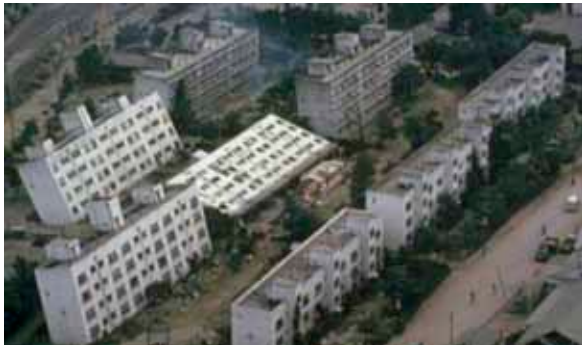
Fig. 6 :Toppling of Apartment buildings at Kawagishi Cho due to foundation soil liquefaction during Niigata earthquake of 1964

the 1964 Niigata earthquake. This resulted in different buildings experiencing different levels of rotation and one of them almost completely toppled. The studies related to liquefaction started gaining importance after this earthquake.

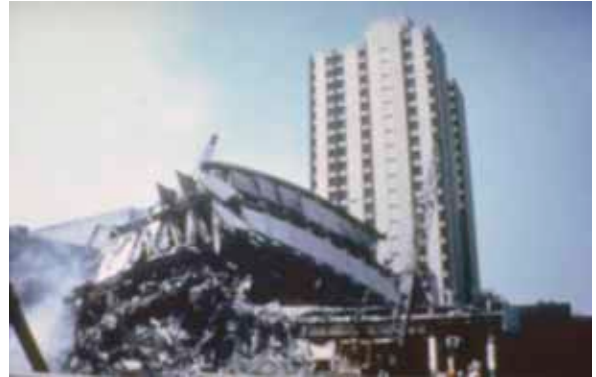
Fig. 7: Total collapse of 21-story steel frame office Building and building standing in background during Mexico earthquake of 1985

The Fig. 7 presents the performances of a twenty one storeyed steel building and another multi storeyed Reinforced Concrete building in the background during the 1985 Mexico earthquake. While the steel structure was completely destroyed the other building was intact after the earthquake. This earthquake clearly brought out the site effect. The depth of overburden, number of layers, depth of ground water table and type of soil etc., provide different responses at the ground level and different structures perform differently. There are possibilities of resonance affecting a particular type of building during some earthquakes at different locations. The Fig. 8 presents the level of deformation

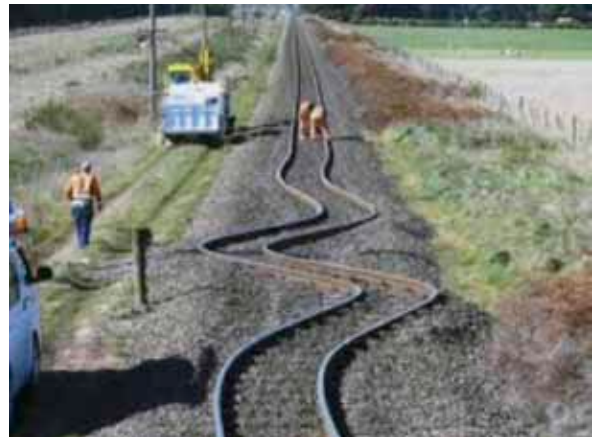
Fig. 8: Railway track subjected to shear due to ground movement during Canterbury earthquake of 2010

experienced at the ground level during the Canterbury earthquake of 2010 in New Zealand. The amount of shear experienced by the ground is visible by the distortion suffered by railway track.

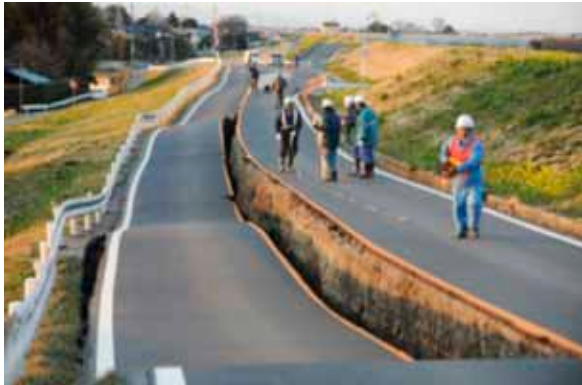
Fig. 9: Half of the highway on gentle slope experienced slide while the other half was intact during the East Japan earthquake of 2011

The Fig. 9 shows the performance of a two lane highway on a gentle manmade slope during the East Japan earthquake of 2011. It is interesting that the lower half of the road suffered a slide down wards along the slope while the other half remained intact. It is really difficult to answer why exactly one half experienced slope failure. Perhaps the compaction was not proper, the effect of shaking was more or soil was poor in the lower half. The Fig. 10 shows a manhole 373 km away from the epicentre of the same earthquake in Tokyo having come up as if to see what is on ground. It appears that manhole was bored to be underneath the ground. This is due to the effect of liquefaction

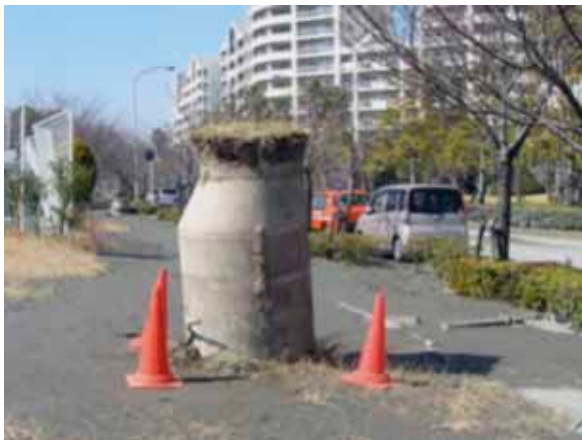
Fig. 10: Manhole above ground during East Japan earthquake of 2011 at Tokyo 373 km away from epicentre. (Photo: Prof. Towhata)

that generated excess pore water pressure which was sufficient to lift the relatively light weight manhole up to ground level. What is surprising is how much seismic force was generated to liquefy the ground so far away from the epicentre.

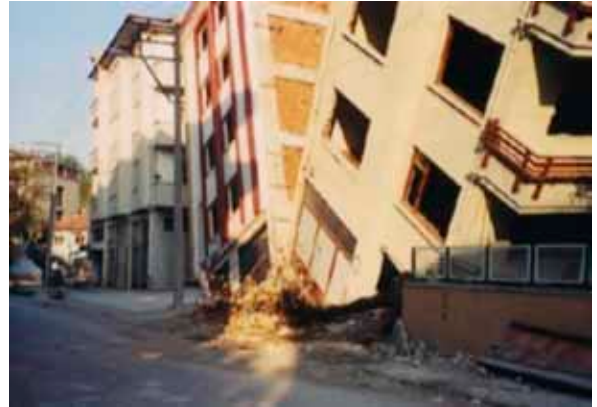
Fig. 11: Two apartment buildings leaning in opposite directions because of ground liquefaction during Izmit earthquake of 1999

The Fig. 11 shows the performance of two reinforced concrete buildings in Adapazari during the Izmit earthquake of 1999 in Turkey. It is interesting that the two buildings experienced lean in opposite directions as if they are angry on each other. This is the effect of liquefaction of foundation soil leading to loss of strength and stiffness. Liquefied ground resulted in the buildings to be unstable and tilt in the direction where the weight was more concentrated. The Fig. 12 shows a bus precariously standing on the elevated Hanshin express way in Kobe after the Hyogo Ken Nambu earthquake of 1995 in Japan. The movement

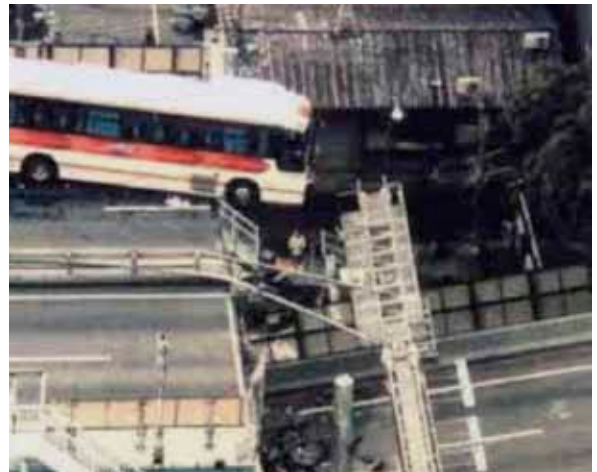
Fig. 12: Deck slab of elevated road displaced due to support movement during the Hyogo Ken Nambu earthquake of 1995 leaving the bus cantilevering precariously

of foundation soil below shifted the piers relative to one another resulting in the slide of top deck slab. The driver of the bus must be really praying for his luck.

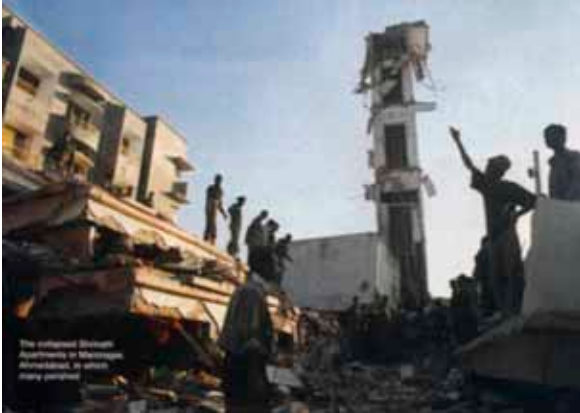
Fig. 13: Lift portion of an apartment building intact while the rest of the structure has collapsed in Ahmedabad during Bhuj earthquake of 2001

The Fig. 13 presents the case of a collapse of multi-storeyed Reinforced Concrete apartment building during the Bhuj earthquake of 2001. While the entire building collapsed, the lift portion survived. Perhaps the designer was more cautious while dealing with the lift portion as lift generated dynamic force during its motion and provided the lift portion within four columns. What he forgot was to properly connect this portion with the neighbouring structure and did not perhaps design that portion for any lateral resistance. While the entire frame collapsed, the lift portion stood erect without

any damage. This portion is the earthquake resistant construction and not the rest. The Fig. 14 presents the structure of olden days called Bunga that was common in Gujarat and Rajasthan about 200 years back. NGOs built a model of Bunga to state that such Bungas survived many earthquakes and testing time with other extreme loadings while the present day structures built by today's engineers cannot survive such lateral forces. Hence, the inference drawn by the NGOs is that it is the civil engineers who kill people and not the earthquakes. Can we accept such statements as Civil Engineers? Definitely, it is not possible to accept. Today's Civil engineer is much more knowledgeable than the one of the past. We can design and construct more complex structures under difficult conditions. However, we still have a long way to go to understand nature. As a Civil Engineer, one cannot accept that we are the killers. But, we all have to work with more caution, and proper coordination for construction under difficult situations.
